**National Highway  
Traffic Safety  
Administration**

CALSPAN ON-SITE AIR BAG DEPLOYMENT INVESTIGATION  
CALSPAN CASE NO. 92-12  
VEHICLE - POLICE 1991 FORD LTD CROWN VICTORIA  
LOCATION - [REDACTED] CA  
ACCIDENT DATE - [REDACTED] 1992

Contract No. DTNH22-87-C-27169

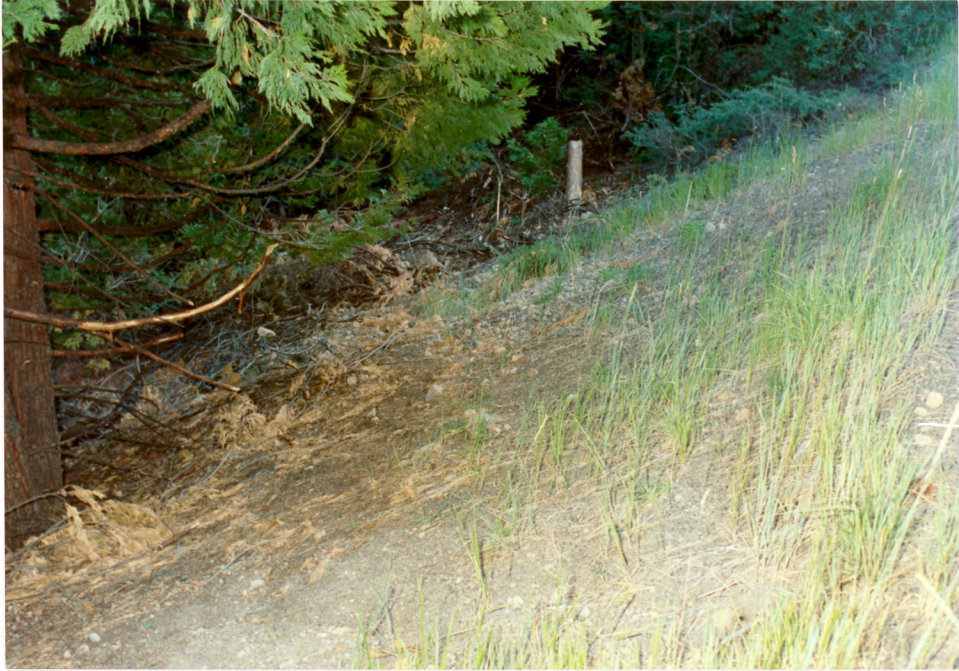
The vehicle began to pitch to its right as its center of gravity continued in a southwesterly direction. The upper surface of the right front fender and hood impacted a 20.3cm (8") diameter tree that was located 9.1m (30') outboard of the roadedge. At impact with the tree, the vehicle had traveled approximately 23m (75') along the embankment. Due to the lateral pitching of the vehicle, the resultant direction of force was non-horizontal (00 o'clock). The vehicle fractured the tree 81.3cm (32") above ground level and overrode the remaining trunk, displacing the roots of the tree.

Struck Tree Branches  
And 20.3cm (8") and 25.4cm (10") Diameter Cedar Trees.

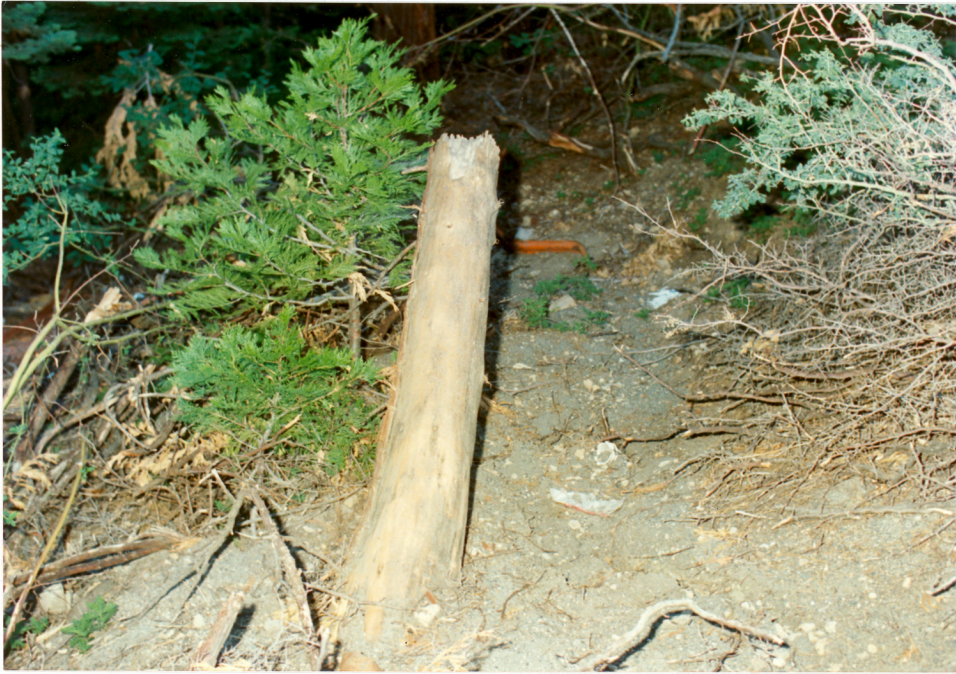
The right passenger compartment area of the vehicle subsequently impacted a 25.4cm (10") diameter cedar tree that was located 2.4m (8') east of the struck 20.3cm (8") diameter tree. At impact with the tree, the vehicle was pitched slightly to its right and struck the tree with its right roof, siderail, door and sill areas. Maximum crush was 83.8cm (33") located on the siderail at the B-pillar area. Again, the vehicle fractured the 25.4cm (10") diameter tree 1.9m (6'3") above the ground and deflected the remaining stump to the east as it overrode the tree trunk. The force of the impact hurled the upper portion of the tree into a wooded area where it came to rest 6.1m (20') to the east of its struck location.

Final Impact Sequence Against The 25.4cm (10") Diameter Tree.

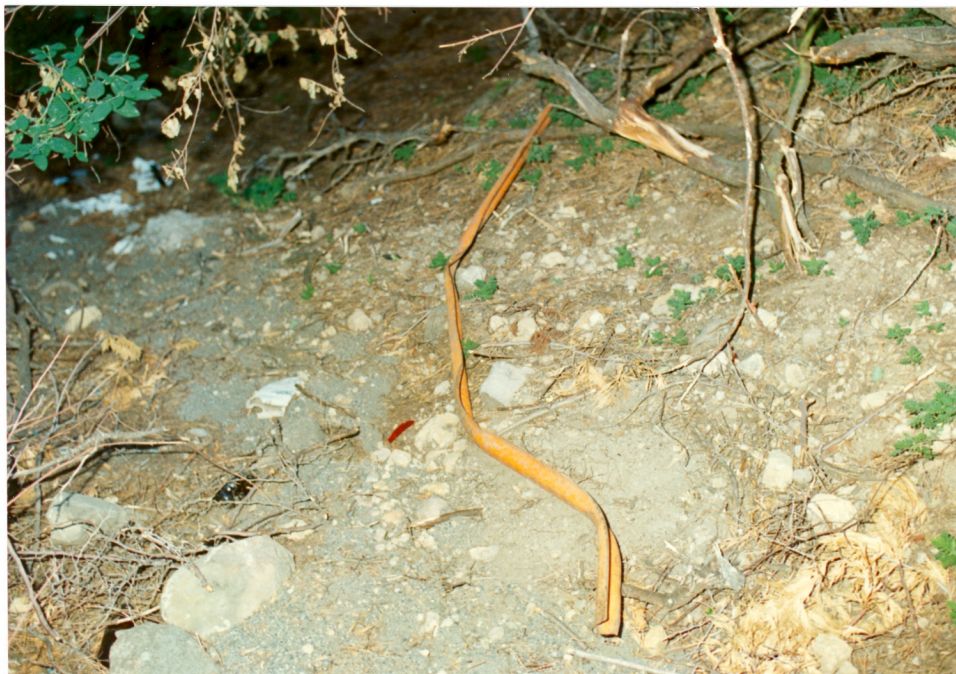
The right front fender of the Crown Victoria impacted and dislodged a steel delineator post from the cinder and earth south shoulder. The impact resulted in minor damage to the vehicle and produced an impact force of 2 o'clock. Again, the minor severity impact with the delineator did not alter the trajectory of the vehicle.

Struck And Displaced Delineator Post.

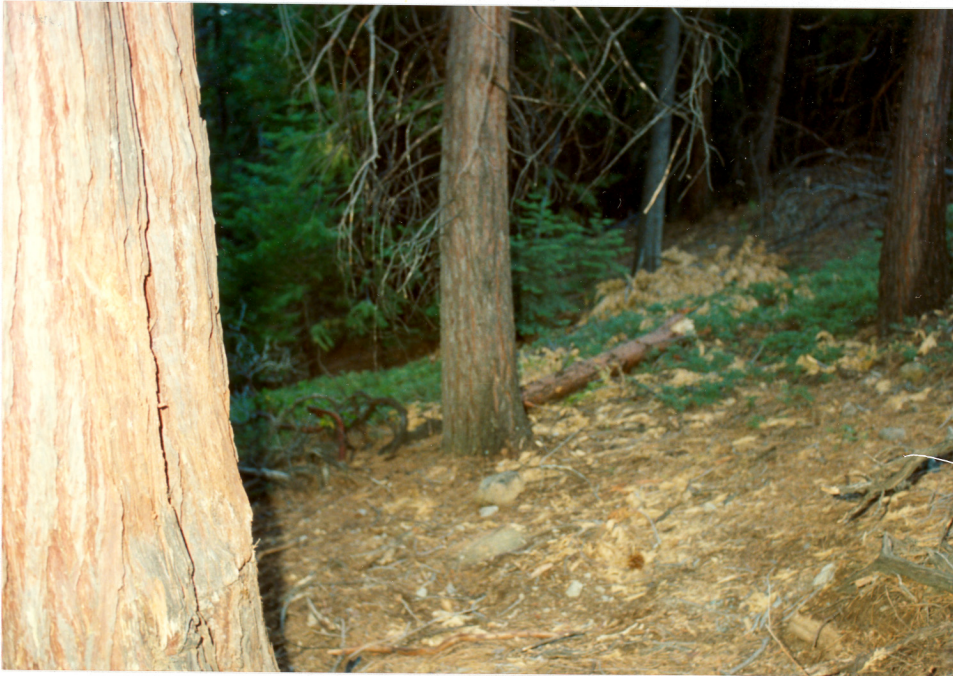
Mid Section Of The Struck  
And Fractured 25.4cm (10") Diameter Tree.

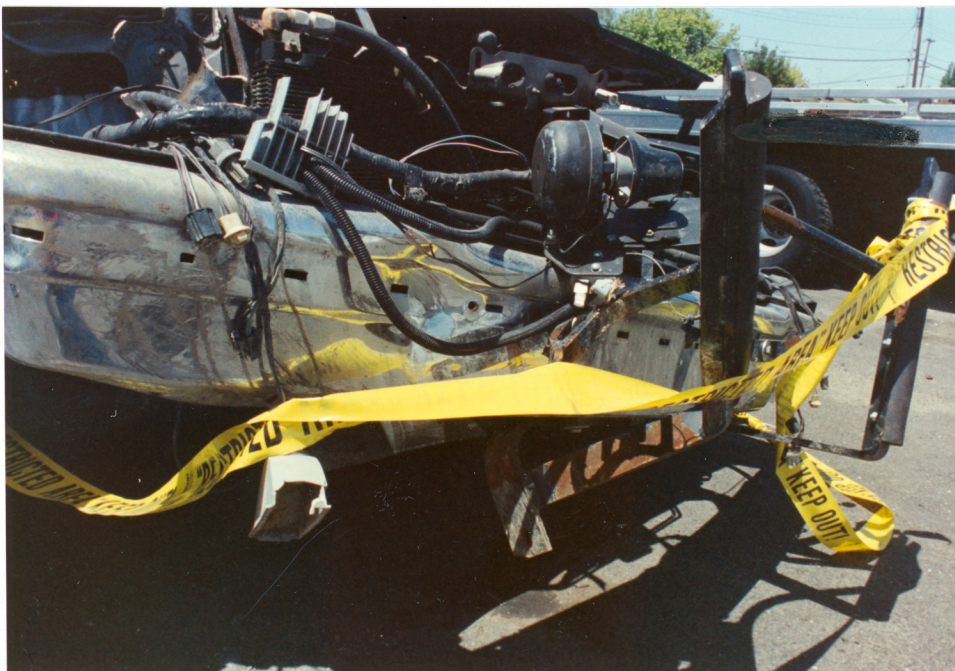
Tree Impact Damage To The Right Bumper Push Bar.

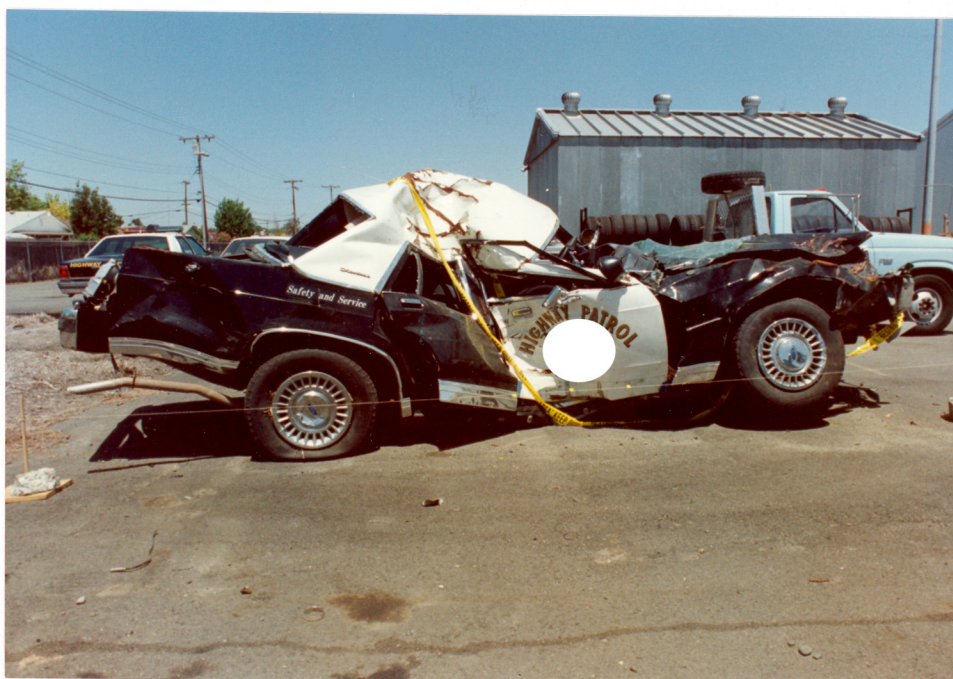
The Crown Victoria continued to pitch to its right and subsequently impacted a 25.4cm (10") diameter cedar tree that was located 2.4m (8') east of the previously struck 8" diameter tree. The impact damage extended vertically from the sill of the vehicle onto the side rail and roof. Due to the slope of the embankment and the vehicle's attitude at impact, the damage was diagonally orientated on the right passenger compartment area. Direct contact damage on the right front door and sill area began 111.8cm (44") rearward of the right front axle and extended 35.6cm (14") rearward. The direct contact damage on the right roof side rail began 162.6cm (64") rearward of the axle position and extended 33cm (13") rearward. Maximum crush was 83.8cm (33") located on the right roof side rail at the B-pillar. Crush values at the side rail level were as follows:

Primary Impact Damage To The Right Passenger Compartment Area.

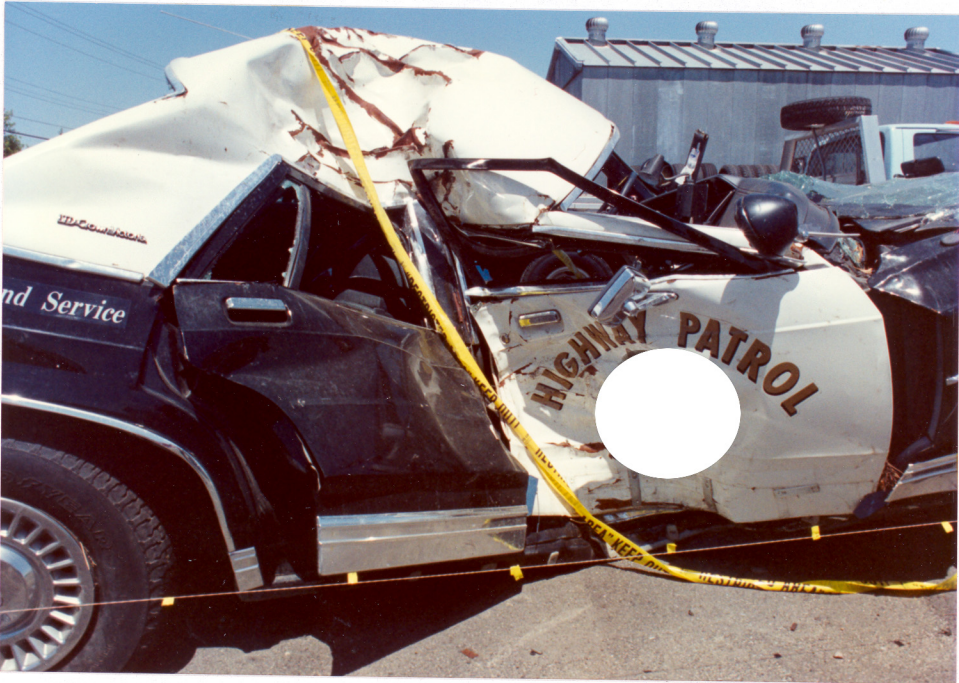
The interior of the Ford Crown Victoria was severely damaged as a result of exterior deformation and driver contact. The right passenger side impact with the 50.8cm (10") diameter tree produced severe intrusion of the right side components. Maximum intrusion involved 83.8cm (33") of lateral displacement of the right roof side rail, the roof and the upper B-pillar at the side rail juncture. Due to the severe lateral displacement of the side rail, the roof was crushed to a near vertical surface on the interior of the vehicle. The mid right B-pillar and right front door panel intruded into the center front occupant space, resulting in a lateral displacement of 76.7cm (30.2").

Overhead View Showing The Extent Of Crush.

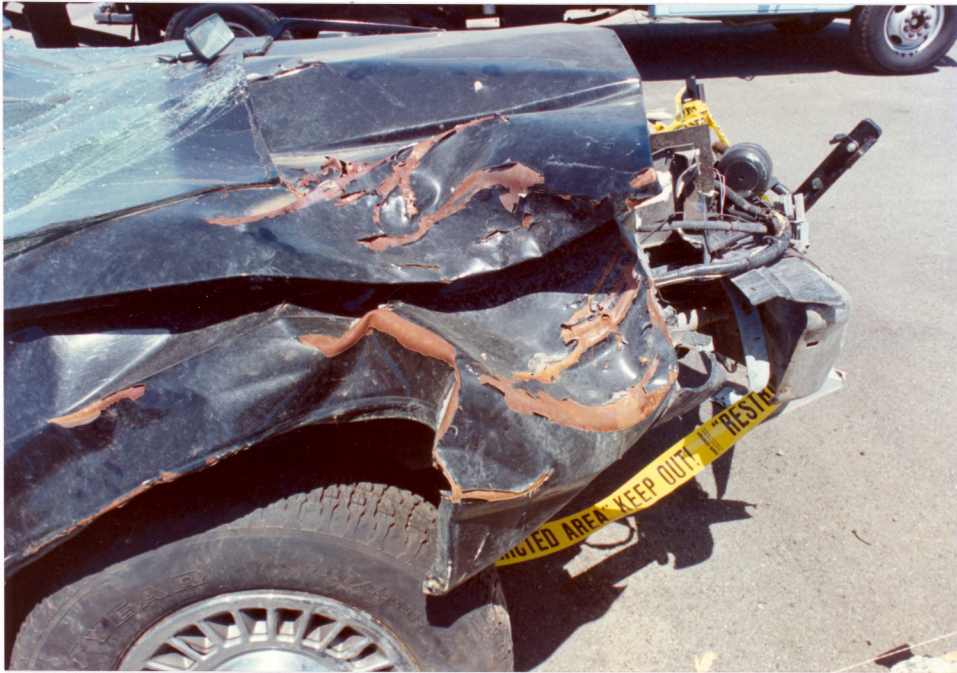
Due to the slope of the embankment, the broadside trajectory of the vehicle, and vehicle contact with the ground, the Crown Victoria began to pitch to its right. The upper surface of the right front fender impacted a 20.3cm (8") diameter cedar tree that was located 9.1m (30') outboard of the roadedge. The tree impact damage began on the fender at bumper level and extended vertically onto the top of the fender and hood, indicating a non-horizontal (00-LFMN-3)) impact force. Direct contact damage began 40.6cm (16") forward of the axle position and extended 20.3cm (8") forward to the leading edge of the fender. The vehicle subsequently impacted a small diameter tree with the right front fender area. The damage was located 16.5-30.5cm (6.5-12") forward of the referenced axle position and involved 7.6cm (3") of crush on the lip of the wheel opening. The

Tree Impact Damage To The Right Front Fender Area.

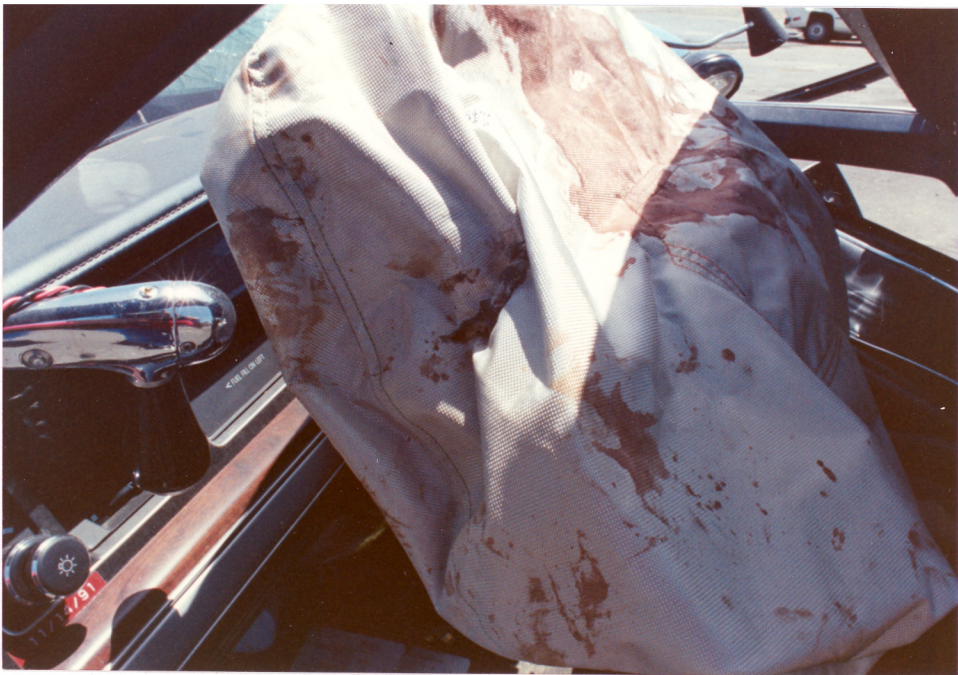
The upper center portion of the air bag was heavily stained by blood from the driver as he came to rest slumped against the deflated air bag. His left hand came to rest under the upper module flap and was pressed against the air bag and the inflator housing. As a result of contact with the hot inflator housing, the heat was transmitted through the bag which subsequently burned the dorsal surface of his left middle, ring, and fifth fingers. The contact also melted the face of the bag at the 9:30 o'clock position. The melted area measured 1.3 x 7.0cm (0.5 x 2.75") and was horizontally located 8.3-9.5cm (3.25-3.75") above the mid point of the bag and 19.1-26cm (7.5-10.25") left of the vertical centerline. The melted area was also located 4.4-10.2cm (1.75-4.0") inboard and toward the driver from the peripheral seam. Upon magnification of the melted area, tissue fragments and blood were found fused to the nylon fabric.

Melted Area Of The Deployed Air Bag.

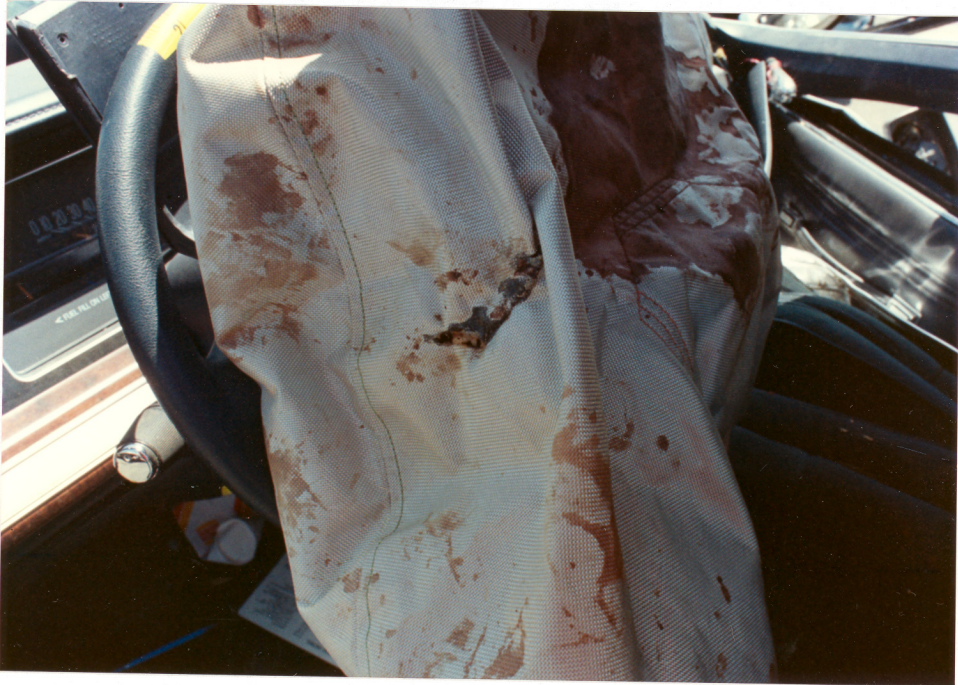
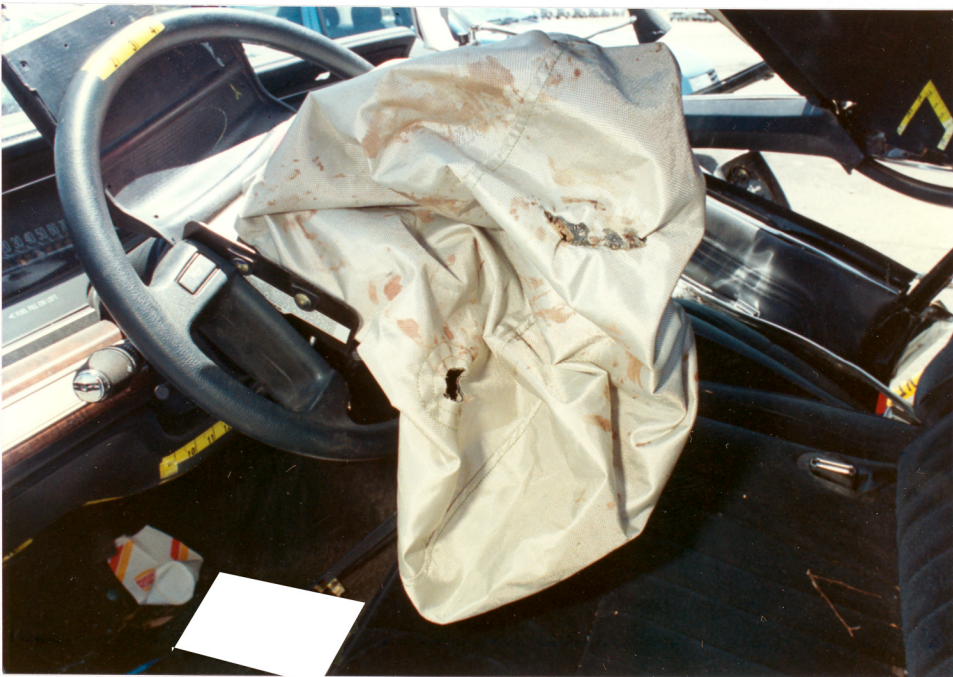
Additional Views Of The Melted Area Of The Air Bag.

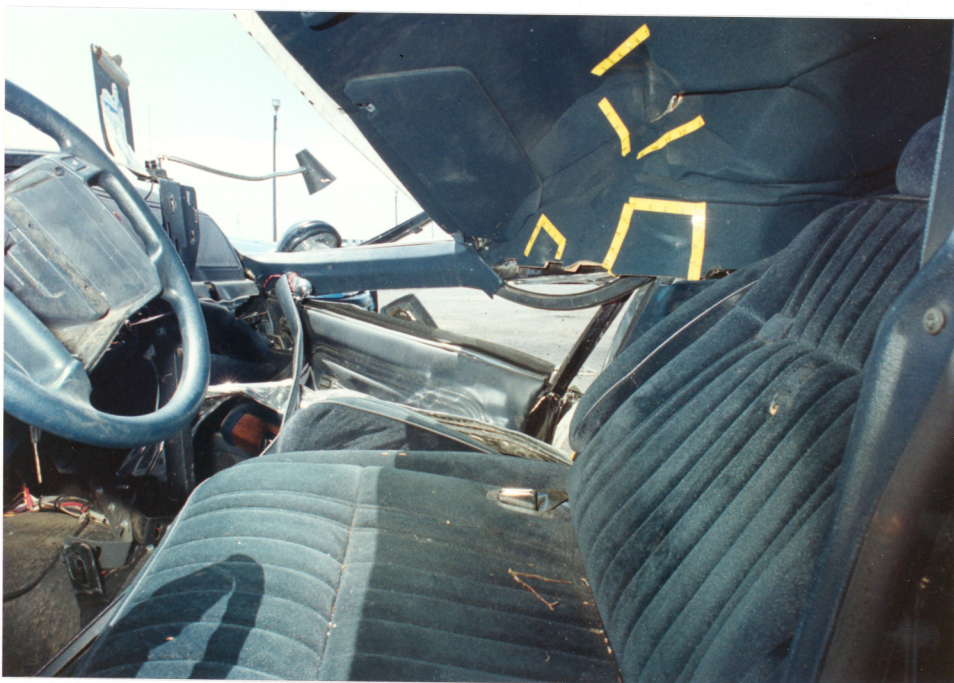
The driver's head and facial areas impacted the intruding vertical surface of the roof. The 11.4cm (4.5") diameter contact cracked the backer panel to the headliner and bowed the roof panel outward .6cm (.25"). The contact point was located 38-51cm (15-20") rearward of the A-pillar and 22-34cm (8.8-13.3") above the roof side rail. His right forearm impacted the right siderail 20-29cm (8-11.5") rearward of the A-pillar, depositing tissue transfers on the fabric covering. The driver's thoracic area contacted the B-pillar; however, no

Head Contact To Headliner And Roof.

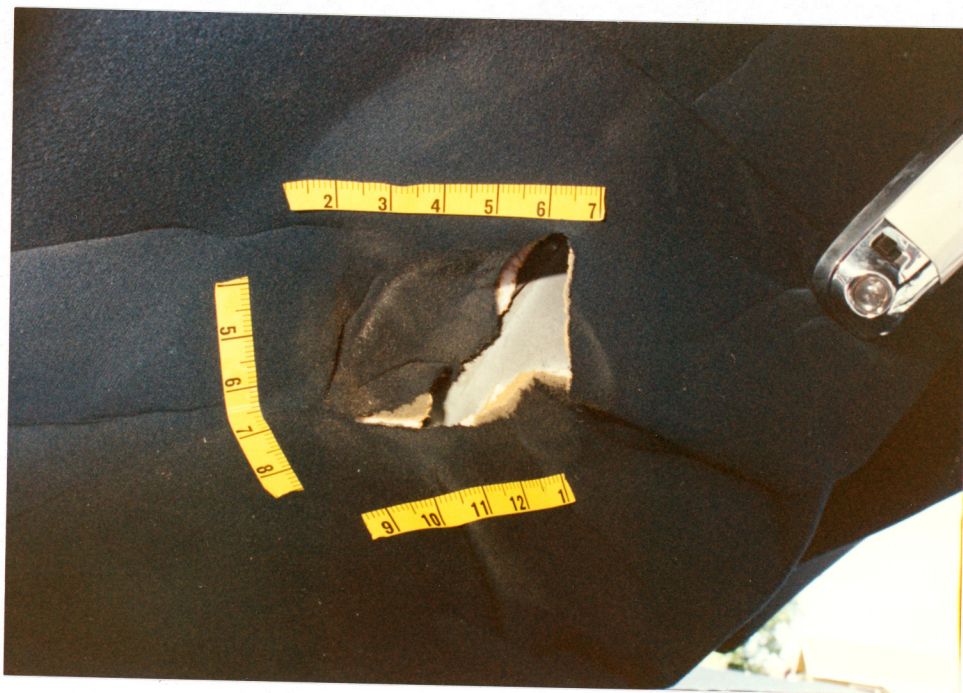
The driver's right forearm flailed upward with respect to his seated position and impacted the intruding right roof siderail 20.3-29.2cm (8-11.5") rearward of the upper A-pillar. Tissue transfers evidenced the contact which resulted in a comminuted fracture of the right radial head and a fracture of the right proximal ulna. The driver's right shoulder subsequently impacted and scuffed the intruding right roof side rail immediately forward of the B-pillar. The contact fractured the mid-portion of the driver's right clavicle. His right lateral chest area impacted the intruding right upper B-pillar and possibly the struck tree as the vehicle crushed to maximum engagement. Although no contact evidence was visible on the vinyl jacket covering the B-pillar, the driver sustained fractured right ribs 2-9 with flail chest, right pneumothorax, and a right pulmonary contusion.

Right Shoulder And Arm Contacts To The Roof Side Rail.

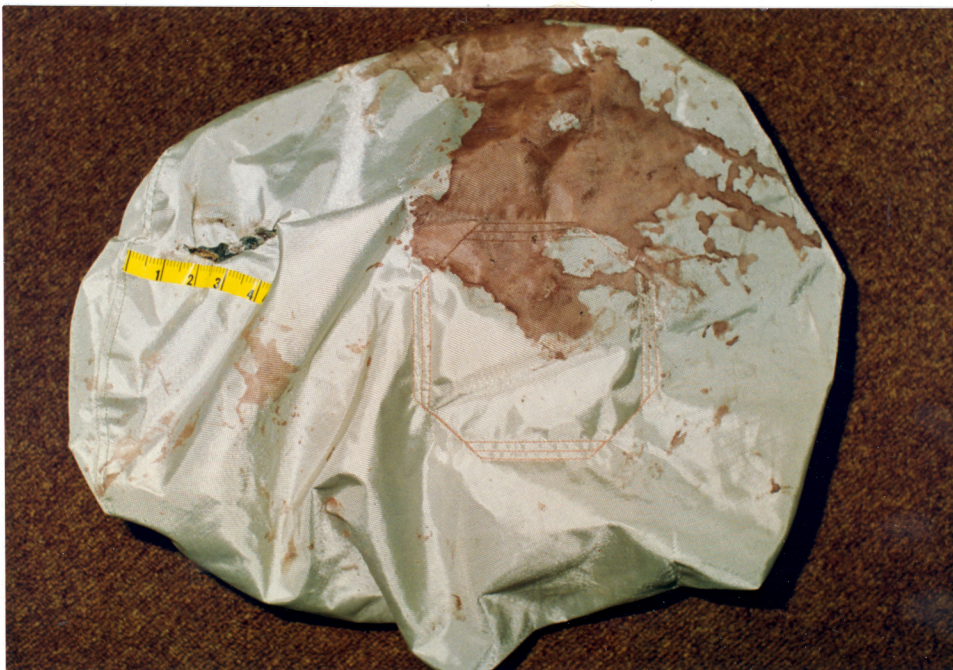
Closeup Views Of The Burned Area.

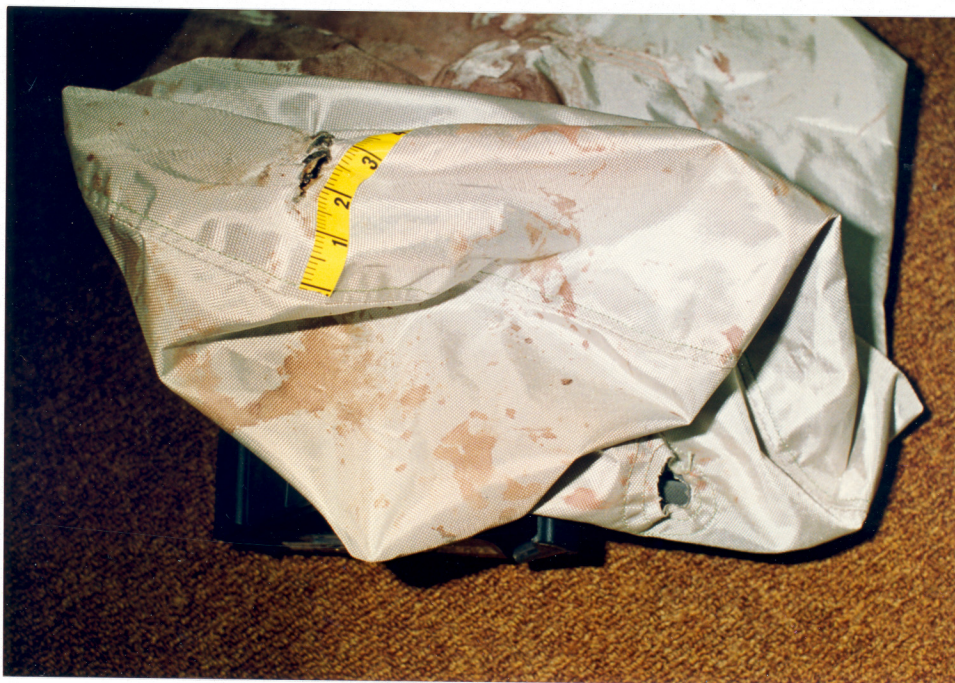
View Of A Melted Internal Tether Strap  
Through The Left Venting Port.

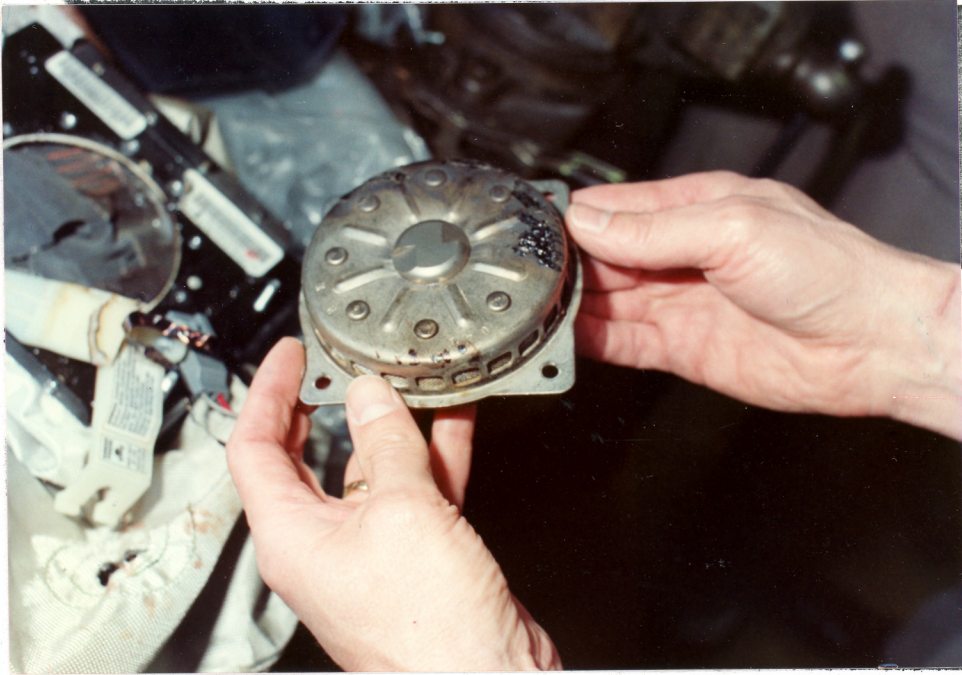
During our on-site investigation of this crash, a representative from TRW (manufacturer of the air bag module) was present to inspect and dismantle the module assembly. During his discussion of the deployment process, he stated that the air bag material, which consists of woven nylon with a neoprene liner, will not support a flame; however, it does have a melting point of 154-177° C. (310-350° F.). The inflation module, which is primarily stainless steel, reaches deployment temperatures of 300° C. (578° F.) and cools slowly due to its isolated, non-vented location.

Melted Bag Material On The Face Of The Inflator.

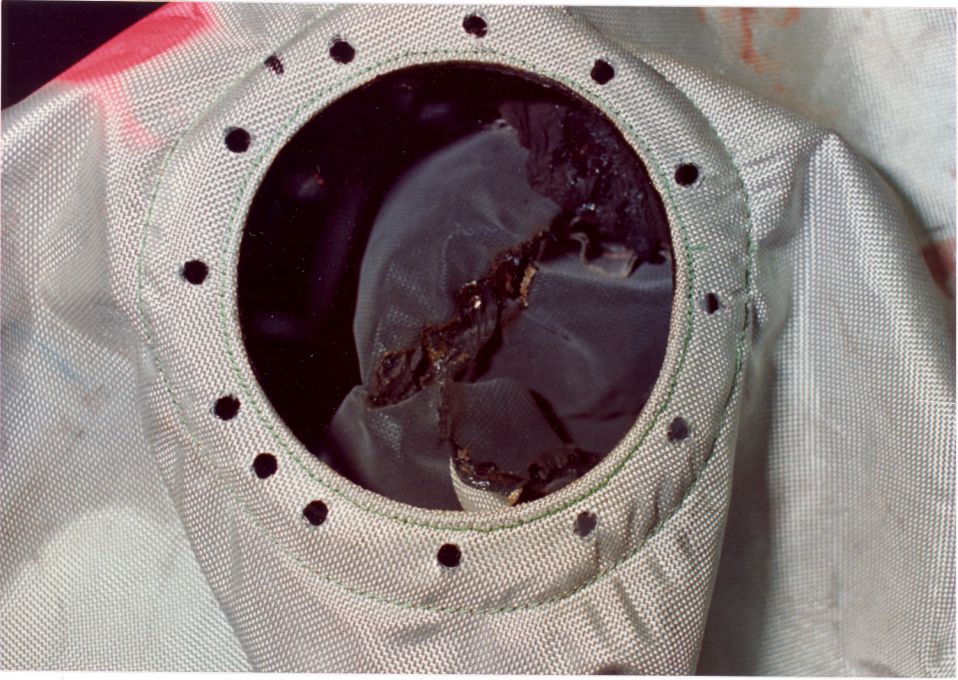
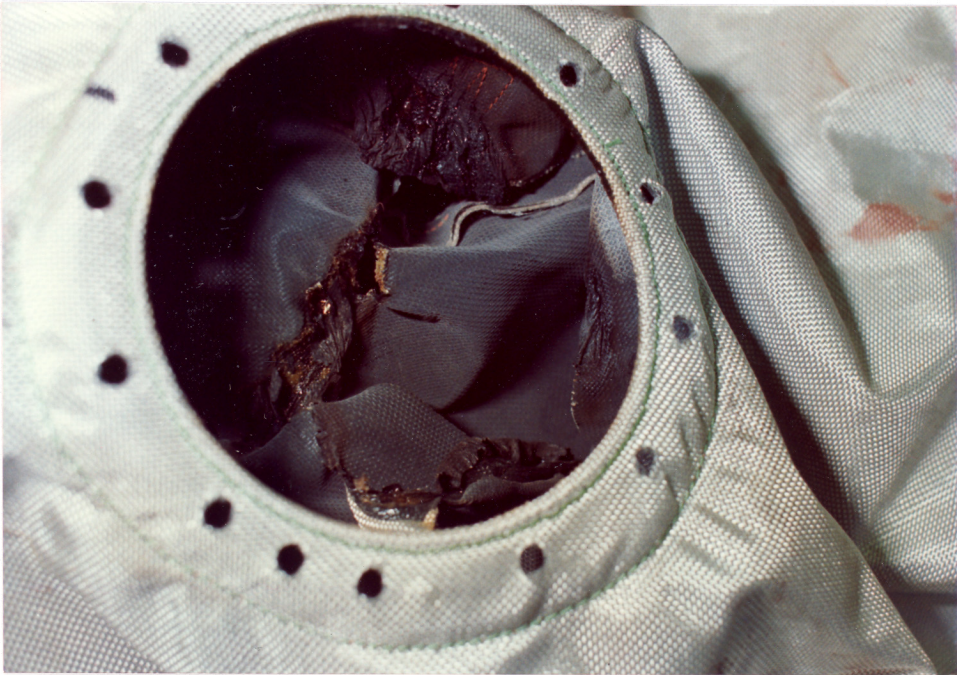
Internal Views Of The Melted Areas Of The Air Bag.

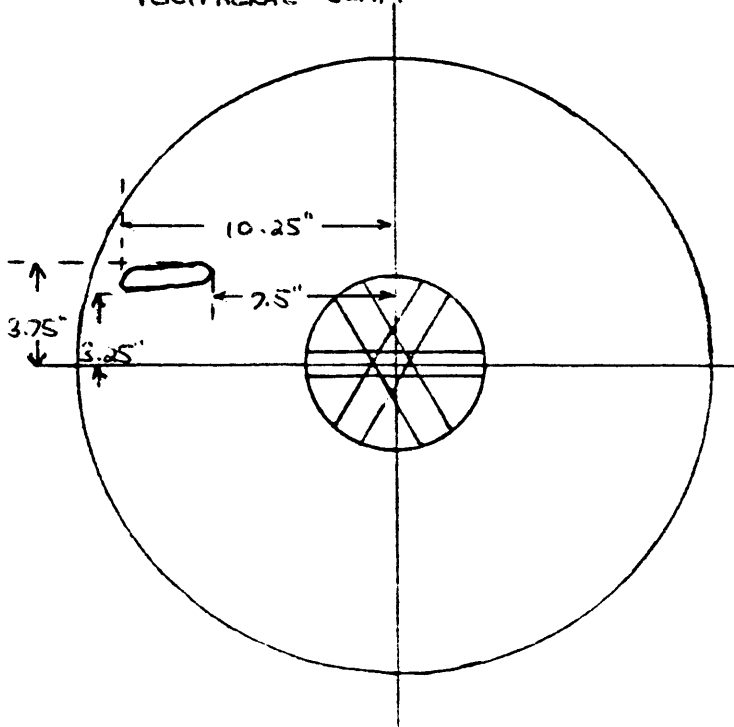
BURN ON FACE OF BAG  
1.75-4.0" INBOARD OF  
PERIPHERAL SEAM
